HAMMER ABUSE/NEGLECT – CAUSE AND EFFECT

Below are some of the most common types of hammer abuse/neglect and the typical causes and evidence of damages that occur from them.

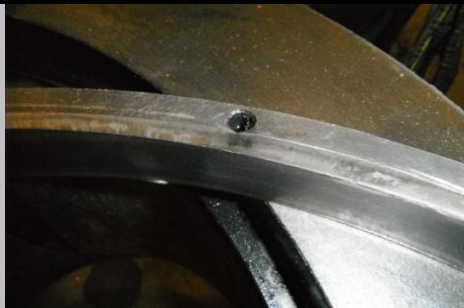
<p>This picture shows the removable catch cap ring (found in newer model hammers) with evidence of it being hit. These rings can be flipped over if opposite side has no damage, or must be replaced.</p>

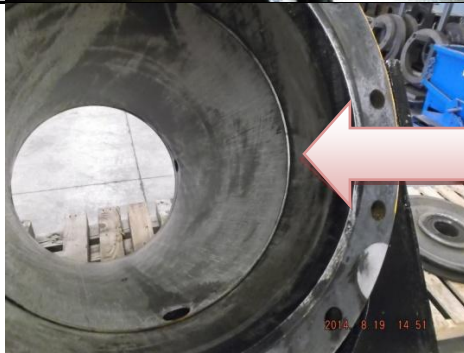
<p>This picture shows the older style catch cap (found in older model hammers), which is a stop edge feature that is machined into the catch cap. To repair this ring, the catch cap needs to be separated from the hammer and be re-machined.</p>

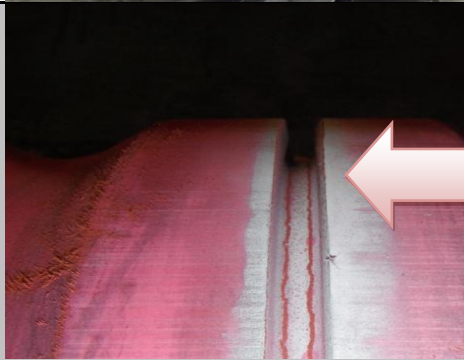
<p>Hitting the catch cap can lead to crack formation on the catch cap groove on the piston. In this location a repair may not be possible.</p>

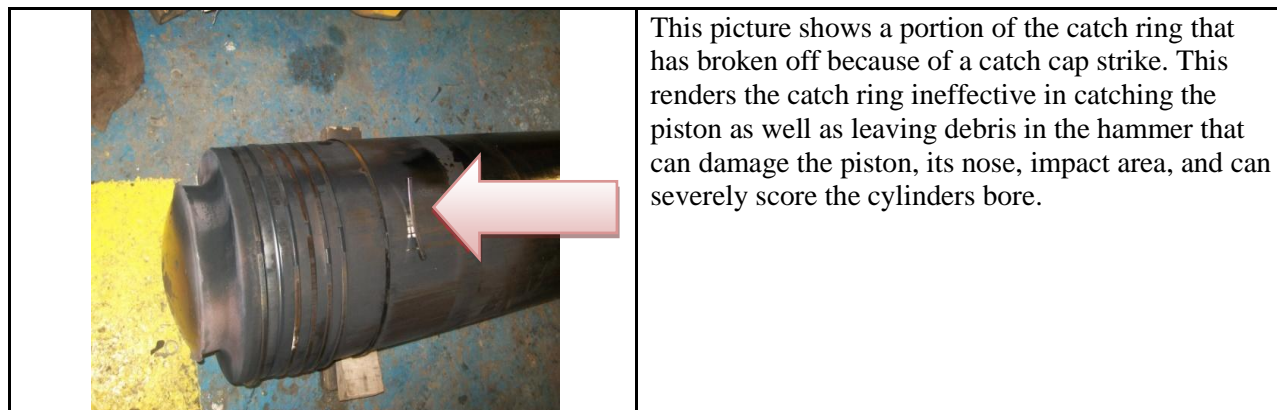
This picture shows a portion of the catch ring that has broken off because of a catch cap strike. This renders the catch ring ineffective in catching the piston as well as leaving debris in the hammer that can damage the piston, its nose, impact area, and can severely score the cylinders bore.

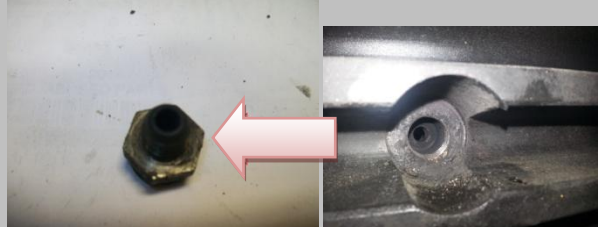
<p>These pictures show a dry grease port. Although this isn't immediate damage it is a clear indicator of insufficient hammer greasing which can accelerate bore wear.</p>

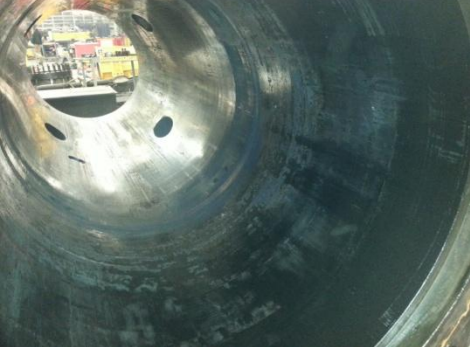
<p>This picture shows a hammer, as received that has little to no oil within it. This results in increased friction while driving, which will not only lower driving energy but also increase heat and stresses within the hammer body. Pitting of the hammer bore and crack formation can result over time which can require cylinder re-sleeving and/or weld repair of the external hammer body.</p>

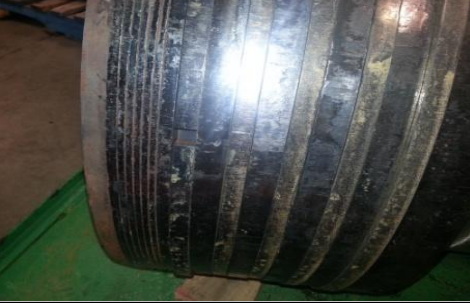
<p>This picture shows an impact block which has evidence of insufficient greasing. The outer body of the impact block shows evidence that it experienced a higher heat as a result (blueing of the metals surface) which can lead to higher stresses and can reduce the life of the impact block. All of the rings will also have to be replaced as they have lost there sealing ability due to collapsed piston rings.</p>

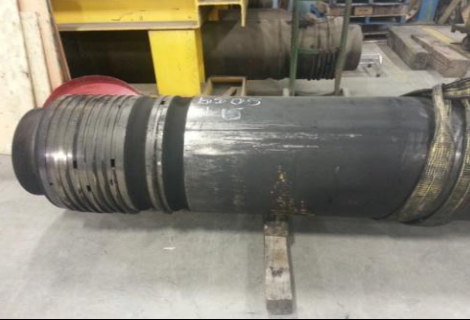
<p>This picture shows a dry piston that was removed from a hammer. The piston can be viewed through the hammers trip slot and the oil pump can be adjusted. If adjusting the oil pump is ineffective, consult the trouble shooting guide to repair the oil pump. The end damage are similar as the impact block under greasing, shown above. (accelerated wear, and premature ring wear).</p>

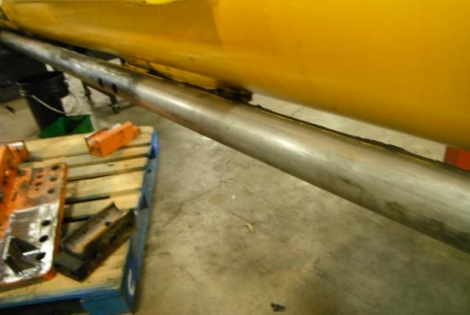
<p>This picture shows trip rails that have not been greased regularly. This increases friction on the rails and accelerates wear on the trip gibs. It also requires more force to trip the piston which gets transferred into the upper body of the hammer and may result in cracks.</p>

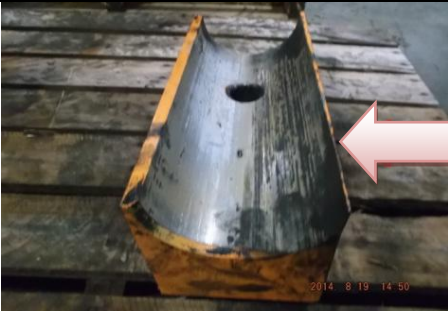
<p>This picture shows excessive wear of a trip gib (due to a lack of grease), but keep in mind the gibs are a wear item. Extreme wear can lead to the hammer not being able to trip out at the proper location.</p>

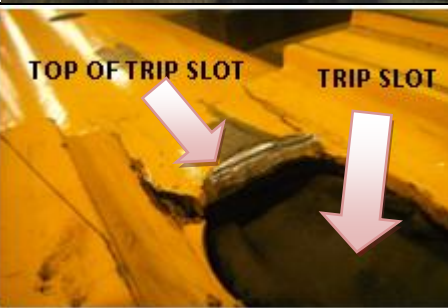
<p>This picture shows the results of worn trip gibs. When the gibs are excessively worn, the trip assembly can operate further away from the hammers body resulting in the lift pawl not disengaging the piston, and can damage the trip slot instead. Cracks can form in this location from the trip-hammer body contact. This is a non repairable crack.</p>

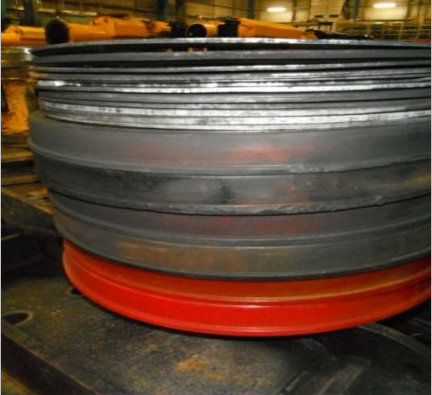
<p>This cushion stack has not been assembled correctly per our cushion stack build procedure. The bottom shows 2 new cushions, stacked up with 4 used cushions followed by all the spacers in one location.</p> <p>This will not distribute the loading through the stack properly and by not evenly distributing the aluminum spacers through the stack, the cushions will lose their elasticity more rapidly.</p>

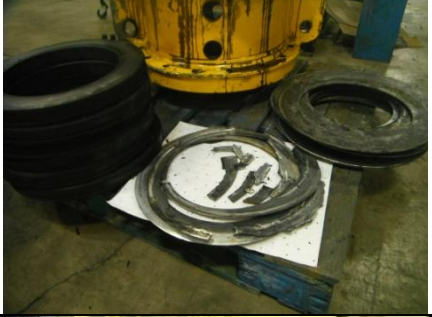
<p>This picture shows a stack that is well beyond needing rebuilding. The aluminium spacers, used for heat distribution, have started to break apart within the stack. At this point the cushions will have lost most of there energy absorption ability. At this point all rings/spacers must be replaced.</p>

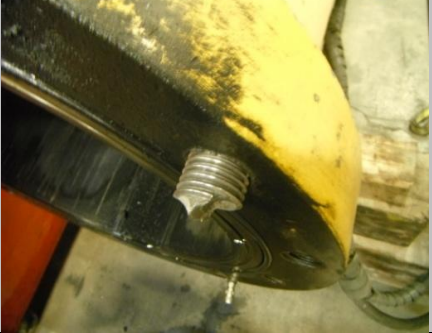
<p>Broken or loosening of bolts can occur when the cushion stack pre-load diminishes, which is a safety concern.</p>

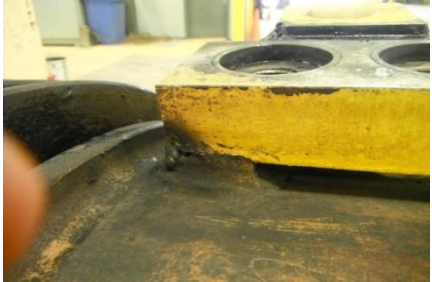
<p>Cracks can form in many areas on the hammer body and its components depending on how long a hammer is run with insufficient cushioning.</p>

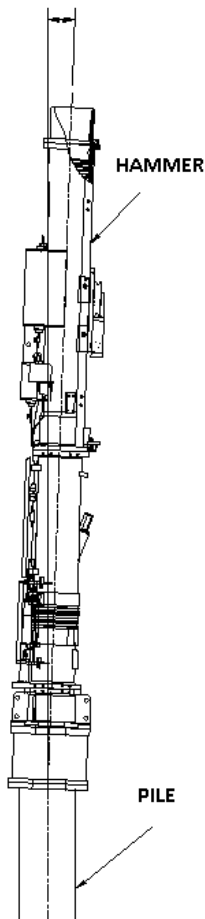
Hammer – pile misalignment	
	<p>This picture shows a guide plate with an uneven wear pattern. This is considered a wear item but considering where the marks are, it indicates that excess hammer forces are bypassing the cushion stack and are being applied directly to the hammer body.</p>
	<p>Broken and loosening bolts can start to occur due to misalignment because the pile is riding the side of the drive housing. This bypasses the hammer cushioning and can load the hammer directly with driving energy. Broken bolts have the potential of letting go of components that are bolted onto the hammer which can fall and result in injury or death.</p>

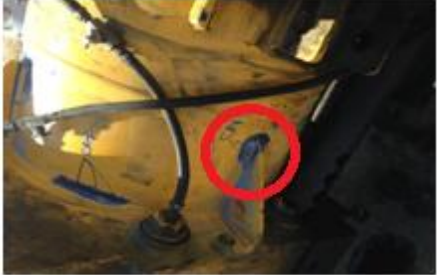
<p>The same as with a worn cushion stack, cracks can eventually form on the hammer body if the misalignment is not corrected.</p>

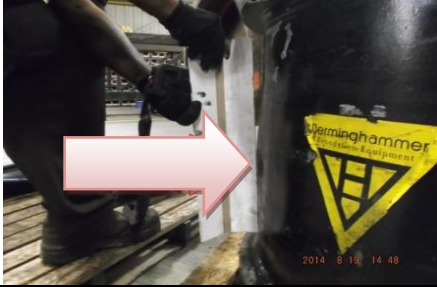
<p>Extreme misalignment over time can damage the direct drive housing. In this case the damage was irreparable and the direct drive housing needed to be replaced.</p>

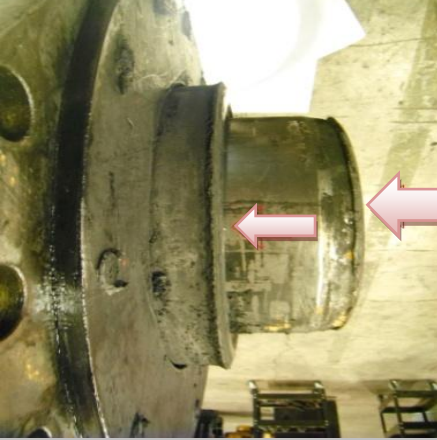
<p>Misalignment of the hammer to the pile can cause an uneven loading condition on the moving parts between the hammers piston and the pile. Specifically between the direct drive striker plate, hammer impact block and hammer cushion retainer ring. These pieces have been designed to take periodic minor misalignment however major or continuous misalignment will overload portions of the contact surface of the parts causing deformations as shown in this picture. It is possible to repair minor misalignment related wear, however major deformations may result in having to scrap the part.</p>

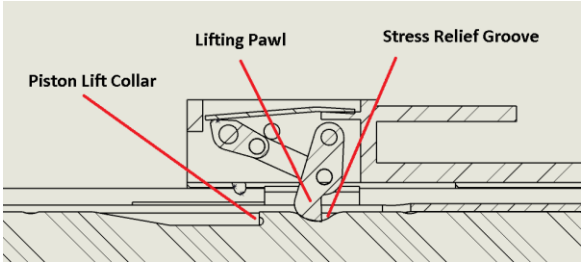
<p>Misalignment of the hammer to the pile can cause the hammer body to get 'hung up' on the pile. This can result, in some cases, for the piston to sit low enough for the trip lifting pawl to engage the hammer within the pistons stress relief feature, above the piston lift collar.</p> <p>This causes the trip to be wedged between the piston and the trip rails, which may cause the inability to disengage the piston from the trip. This will cause severe stresses which may lead to the formation of cracks or other damage.</p>

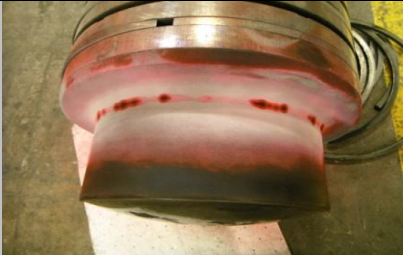
<p>The hammer is designed to drive piles at a reasonable rate. Exceeding these rates can lead to over stressing the components which can lead to cracks on the hammer body or the internal components such as the piston.</p>

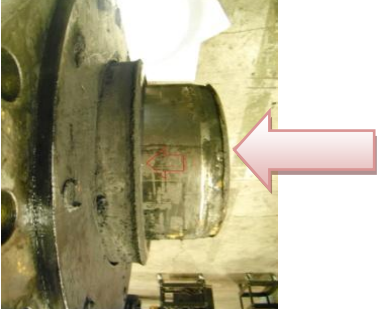
<p>Like misalignment, exceeding the recommended rates of use of the hammer, it can lead to deformations on the internal moving components, such as the piston nose (shown above) the impact block and cushion retainer ring (shown to the left).</p>

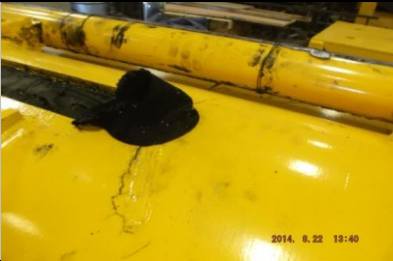
<p>Cracks can form not only though welded components but also though the hammer body as well. Minor cracks may be repaired however large cracks may result in having to replace a cylinder.</p>

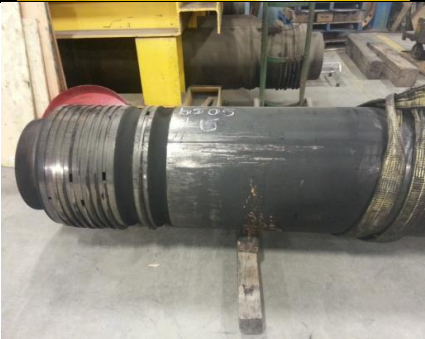
<p>Running the hammer at an increased rate for long periods of time can burn up the lubrication quicker because of the higher heat that is generated. This will cause damage that were previously discussed in the lack of lubrication section such as pitting the cylinders bore, and increased wear of the impact block and piston.</p>

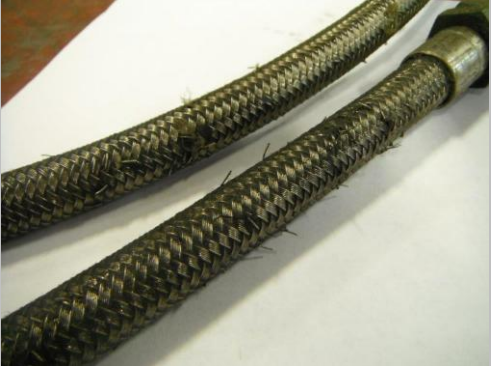
<p>This picture shows fuel lines with visible fraying on the outer wire braid of the line. What it doesn't show is possible fraying of the internal braids which may puncher the inner Teflon core causing the fuel line to leak. This is caused by the lines rubbing other components of the hammer, sharp bends or twisting in the fuel line which synchs up the braids that will cause the line to be less flexible.</p>

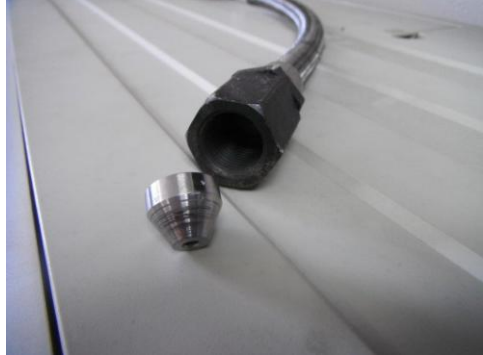
<p>Broken fuel line stems can be the result of excessive tightening and un-tightening of the fittings. This can lead to fatigue cracking which can propagate though the end connection. Excessive twisting of the fuel line can also result in excessive forces being transferred to the end connection which could cause failures.</p>

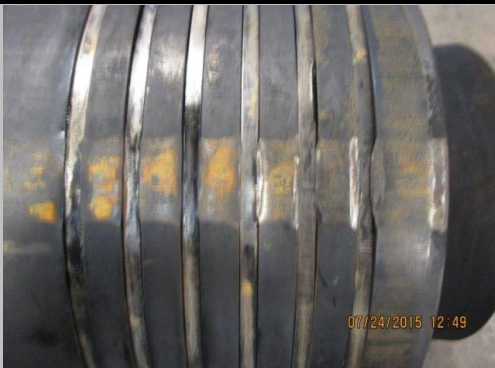
Score marks to piston. Non-critical locations may not have an effect to hammer performance however damage around hammer features may require field fixes or possible machining to get the hammer running.

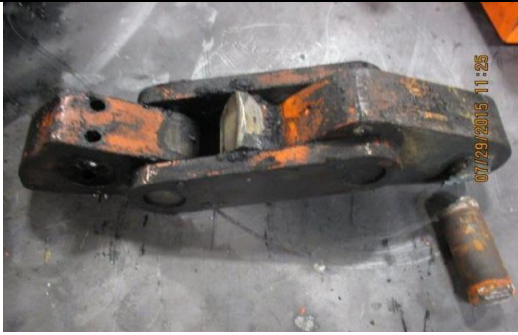
Internal trip components, which see the bulk of this force may require replacing. The pivoting holes which are round may become oval and will not pivot correctly. Pins also may also become bent and require replacing. The lifting pawl, which contacts the piston, can become deformed with the impact event.

In some cases, damage may extend to trip body itself requiring sleeves to be installed in order to maintain pivot points and keep the trip functioning properly.
