HAMMER ABUSE/NEGLECT – CAUSE AND EFFECT

Below are some of the most common types of hammer abuse/neglect and the typical causes and evidence of damages that occur from them.

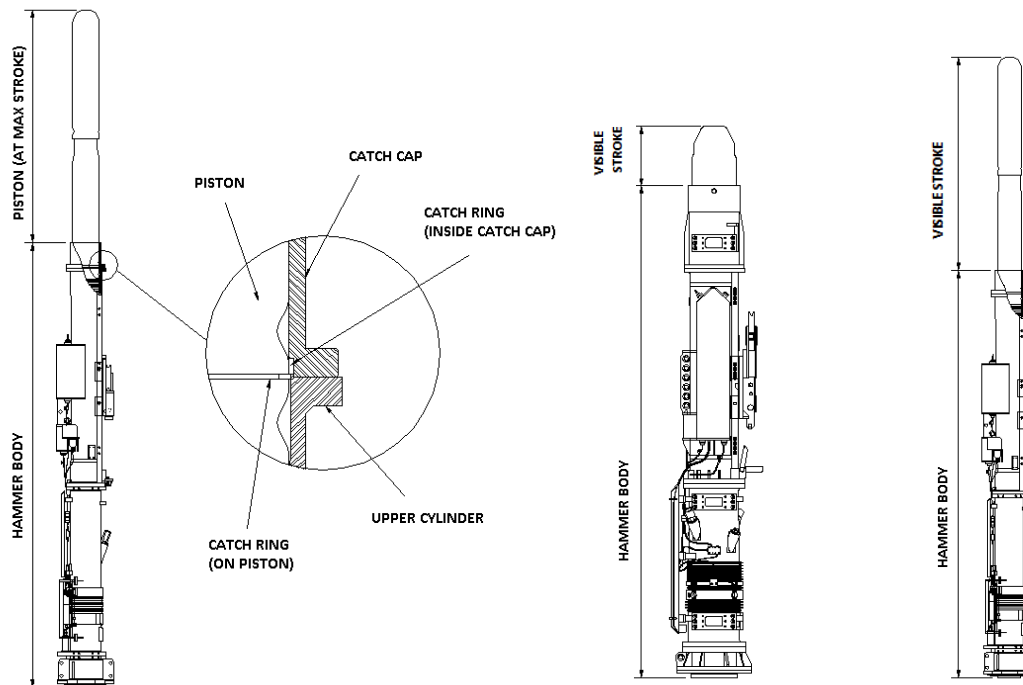
Piston impacting catch cap

Critical safety feature! Shut down hammer and inspect if struck (See below)

Description: The hammers piston has a catch ring that mimics the behaviour of a piston compression ring, however its function is to expand and make contact with a internal lip in the catch cap if the piston is over-stroked. **This event ‘catches’ the piston and prevents it from exiting the hammer, which is an industry standard safety feature for diesel pile hammers.**

Hitting the catch cap is typically indicated by a sudden violent change in the rhythmic sound of the hammers hitting frequency, and is commonly accompanied by the hammer slightly lifting and slamming back down onto the pile. **Being a critical safety feature, anytime the catch cap is struck, the hammer must be stopped and the catch cap ring must be inspected to ensure its stop edge hasn't become rolled or chamfered.** If it has, the ring will need to be remedied.

Cause: To prevent unintended contact of the piston and catch cap we recommend performing a dry drop at the beginning of a shift to purge the cylinder of any diesel or oils that could have accumulated in the combustion chamber. See pocket manual for dry drop instructions.

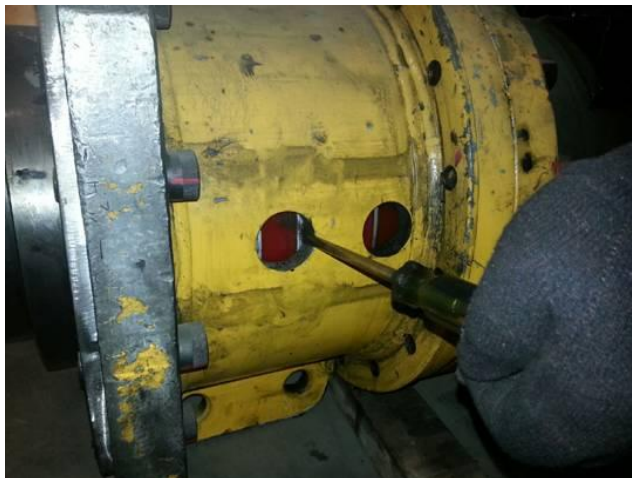
Insufficient pre-load within the cushion stack

Description: The hammer relies on the hammer cushion stack to isolate the pile-hammer interactions so the energy created is not transferred to the hammer body and other hammer components.

Cause: During normal operation, as the cushions start to degrade due to wear and heat, the cushion stack will slowly lose its energy absorption ability and thus will start to lose its pre-load value. As the cushion stack starts to degrade, the cushioning lessens and hammer parts and hardware can start to crack and/or loosen. For this reason, it is imperative to check the cushion stack pre-load. This is accomplished by trying to insert a flat head screwdriver into the stack with minimal effort (50 psi). If the screwdriver cannot be inserted

at all, the cushion stacks is still good. If the screwdriver can be inserted, the cushion stack has expired and is in need of rebuilding. Refer to the Hammer Cushion Stack Build Procedure (found in the Hammer Operation Manual) for the specific model of hammer for process and layout of cushion rings, spacer and required pre-load necessary to build the cushion stack properly.

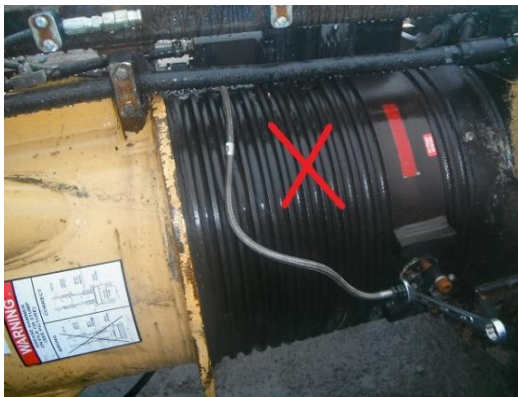
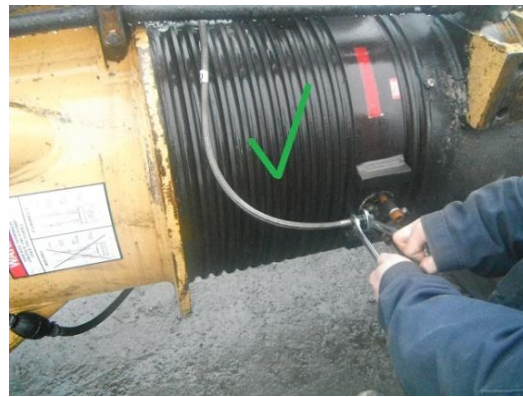
Improper installation or tightening of fuel lines

Description: Improperly installation or tightening of fuel lines can cause premature failures or leaks within the fuel lines.

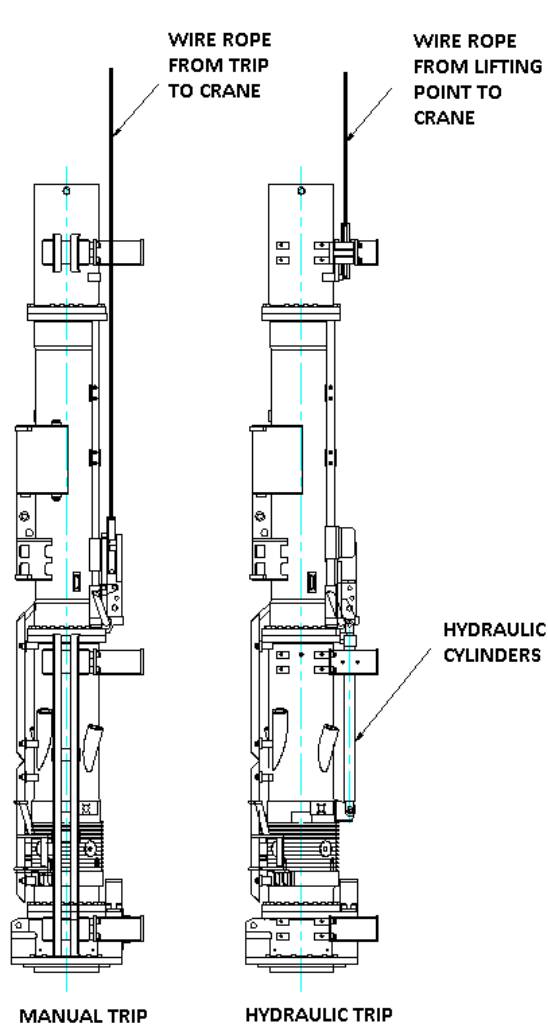
Description: This is when the trip is lowered and is engaged on the trip engagement lug which results in the trip lifting pawl pivoting within bore of the cylinder while the hammer is running. This causes the piston (ram) to make contact with the trip lifting pawl with the driving force of the hammer.

Manual trip: A wire rope is connected to the trip and is directly controlled and positioned by the crane operator by controlling the rate of rotation of the winch that the wire rope is connected to. This method requires the crane operator to adjust the trip position while the hammer is running as the pile is being driven.

- Site personal tie-off the trip lever safety rope so the trip is always engaged and while driving the pile the trip is lowered onto the engagement lug and engages the trip.
- Site personal tie off the trip lever safety rope and there is an unexpected event, such as the hammer hitting the catch cap, resulting in the hammer body to jump which takes up any slack in the trip lever safety rope, and the engagement lug engages the trip.
- The crane operator lowers the trip body too quickly so that there is a violent collision with the bottom part of the trips travel which may result in the trip engaging.

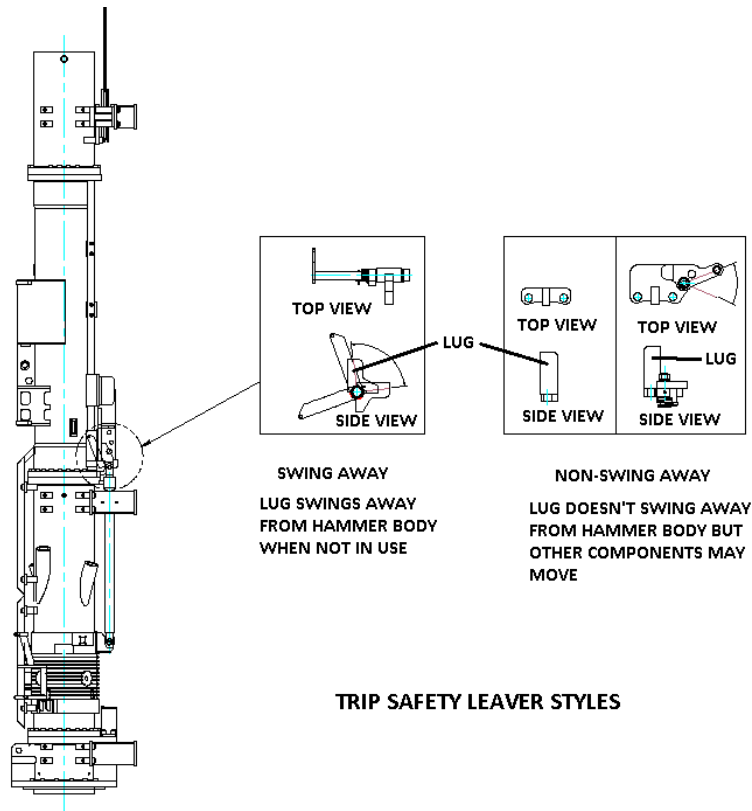
Hydraulic trip: A hydraulic cylinder(s) are connected to the hammer to move the trip up and down with the control of a hydraulic circuit within the crane or on a hydraulic power pack. This tripping method doesn't require adjustments while the pile is being driven. It is however recommended that the hydraulic cylinders are either fully extended if the hammer trip out lever isn't able to swing away from the hammer body or fully retracted if the hammer trip out lever is able to swing away from the hammer, as illustrated below.

- There is a hydraulic leak in the cylinders that isn't corrected before starting the hammer resulting in the trip lowering while in operation and the hammer model doesn't have a swing away trip safety lug or the safety lever rope is tied off.
- The trip is lowered while the hammer is running and the hammer model doesn't have a swing away trip safety lug or the safety lever rope is tied off.
